**Docket No. 217 – Development and Management Plan Inspection**

Northeast Utilities Service Company Certificate of Environmental Compatibility and Public Need for the construction of a 345-kV electric transmission line and reconstruction of an existing 115-kV electric transmission line between Connecticut Light and Power Company's Plumtree Substation in Bethel, through the towns of Redding, Weston, and Wilton, and to the Norwalk Substation in Norwalk, Connecticut.

**Location:** 115 kV Underground Route

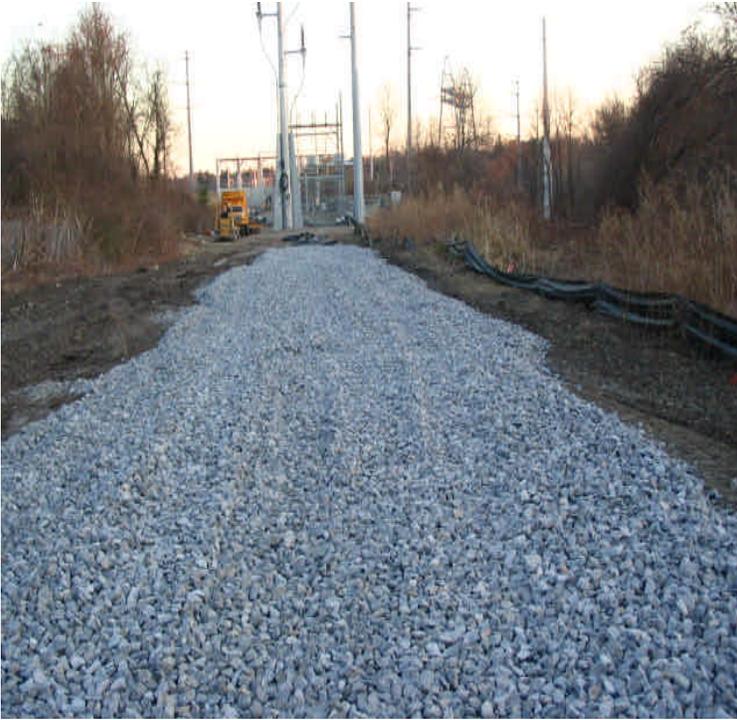
**115kV (Broad St and Putnam Park):** Photo on the left shows where gravel was installed along the ROW in preparation for bike path construction. Silt fence needs attention. Photo on the right shows the Putnam Park storage area: controls remain in good shape. 3/29/06

- The ROW had been placed with stone.3/31/06  - Silt fence could use repair along the ROW, especially prior to work returning here. 3/31/06	- Keep silt fence in good repair until the area is stabilized and the bike path constructed. 3/31/06	
<b>Broad Street, ROW, and Rt. 7 Norwalk</b>			
<b>Soils</b>	-Clean process remains in one pile at the Putnam Park storage area. 12/22-3/31/06	- All soils appear to be handled appropriately. 12/22-3/31/06	-N/A
<b>Adjacent Wetlands and Waterways</b>	-The stream behind the fence at Putnam Park and the wetland swale adjacent to Sunset Hill are	- None at this time. 3/31/06	-N/A

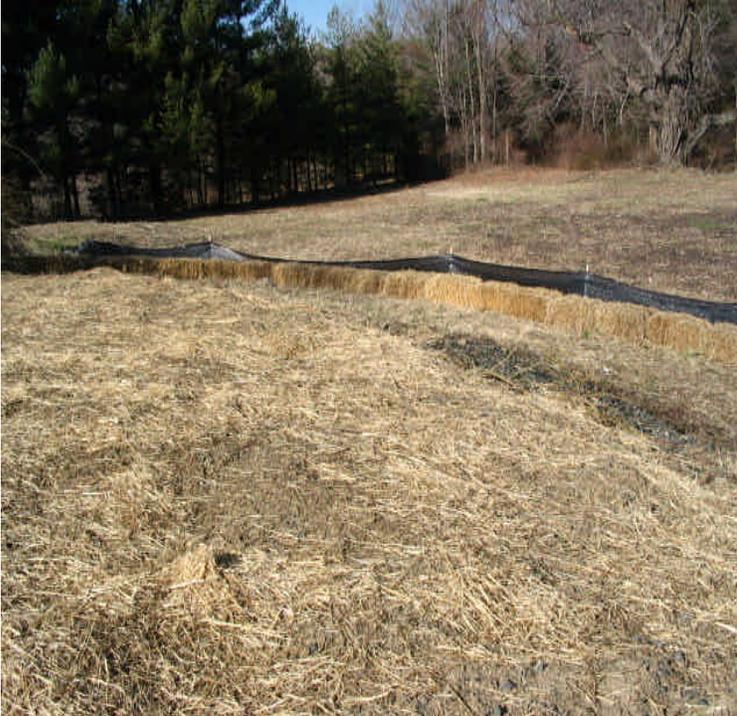
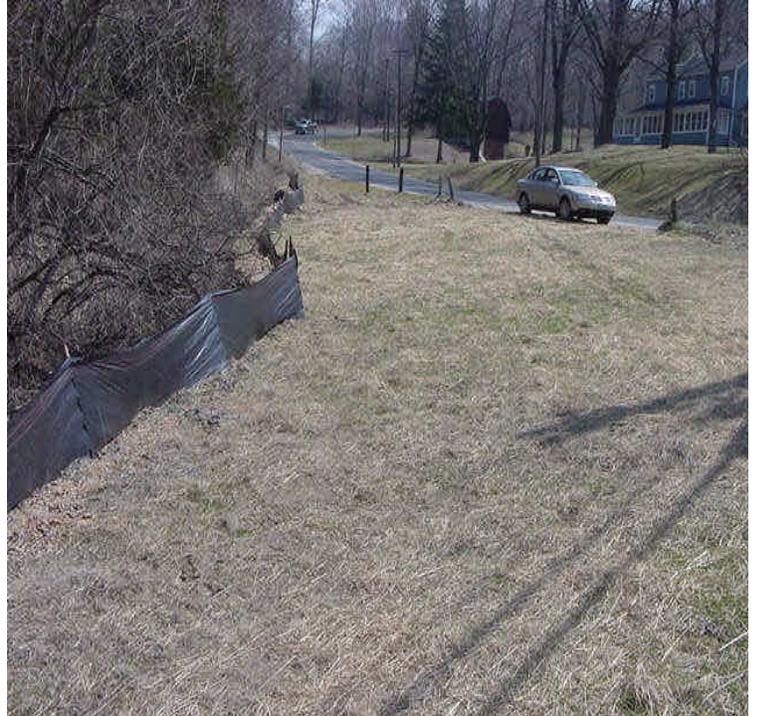
**115kV (Rt 107 and Sunset Hill):** Both storage areas and controls remain in good shape and noticeable grass growth was observed. 3/29 and 3/31/06

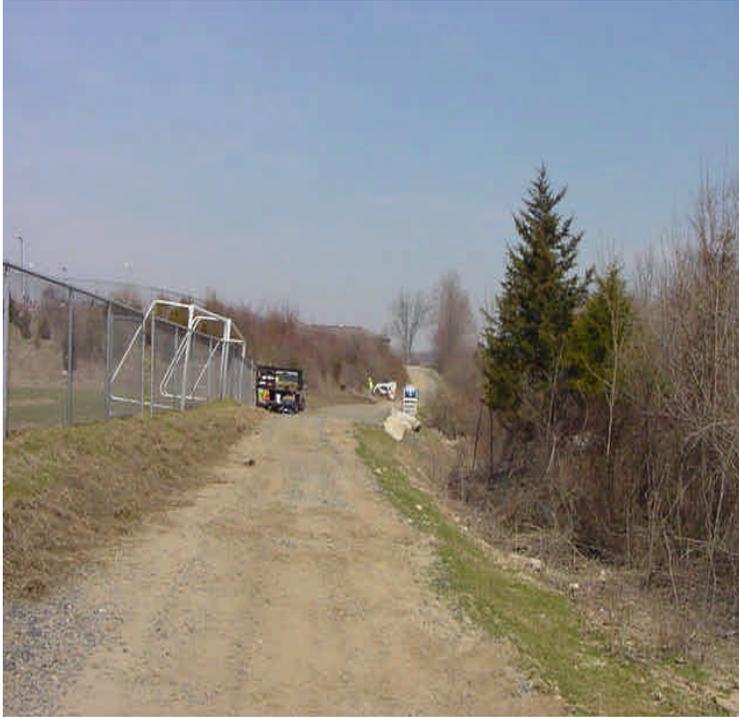
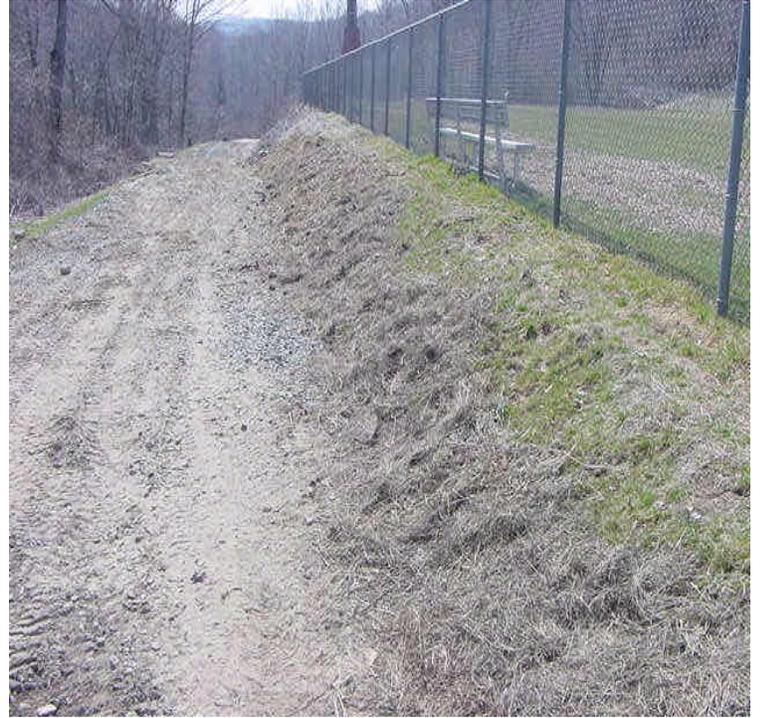
115kV (Bethel Ed.): Both photos show some restoration efforts along the southern portion of the ROW at the Bethel Ed. Park. 3/31/06

Main Ave. / Rt. 7, Norwalk			
Erosion and Sediment Controls			
<b>Bethel Education Park</b>	-Restoration was occurring along the southern ROW. 3/31/06 - Silt fence was removed along the northern ROW but remains near the tower. 3/31/06	-The new stone in the area will likely eliminate washout issues. 3/31/06	-More stone was installed near the washout and areas were being placed with mulch in the southern ROW.

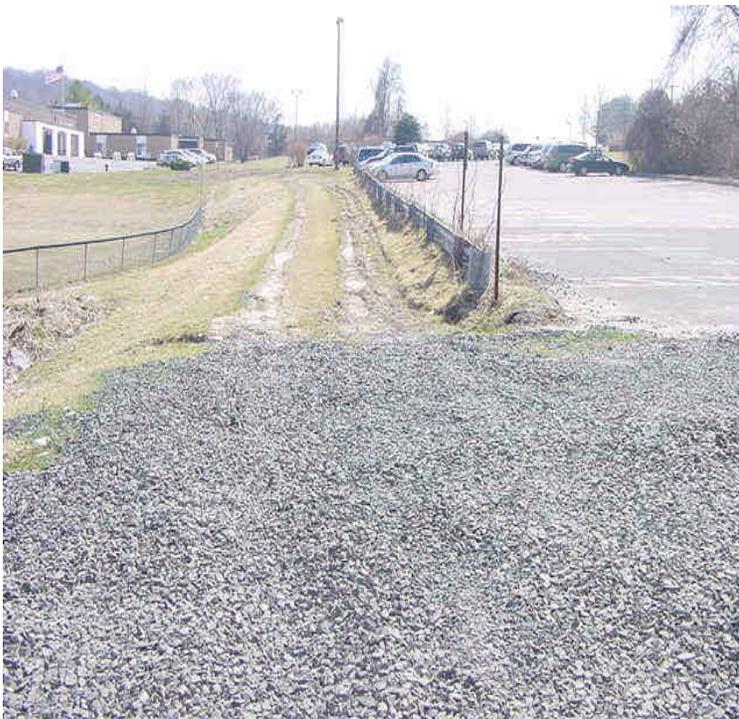
Photo on the left shows were a load of stone was installed over the entire washout/ access area near the north tower. Photo on the right is a view of the tower area. 3/31/06

Areas of Inspection	Observation	Recommended Action	Corrective Action
Vault Openings and Trench Construction	- <b>Bethel Educational Park:</b> - A load of stone was placed near the access to the north tower. 3/31/06	-Final restoration will be needed in the spring. 3/9-3/31/06	-Additional stone was placed over the washout area.
Gallows Hill Road and Rt. 107, Redding	- <b>Hoyts Hill Transition Structure:</b> No remaining activities. 3/31/06	-See EC section. 3/31/06	-N/A
	-Crews arrived to work near the tower at the ROW. 3/31/06	- See EC section. 3/31/06	- N/A
Rt. 58, Bethel	-No activities at this time. 3/31/06	-See EC section. 3/31/06	- N/A
Broad Street/ROW, Norwalk	- A load of stone was installed along the ROW off Broad St. in preparation for the bike path. 3/31/06	- Make sure silt fence is repaired and in good condition prior to work. 3/31/06	
	-No activities at this time. 3/31/06	-None at this time. 3/31/06	-N/A
